**F206**  
**VELCO**

July 15, 2026  
VSPC Meeting  
Frank Etori

# Project Summary

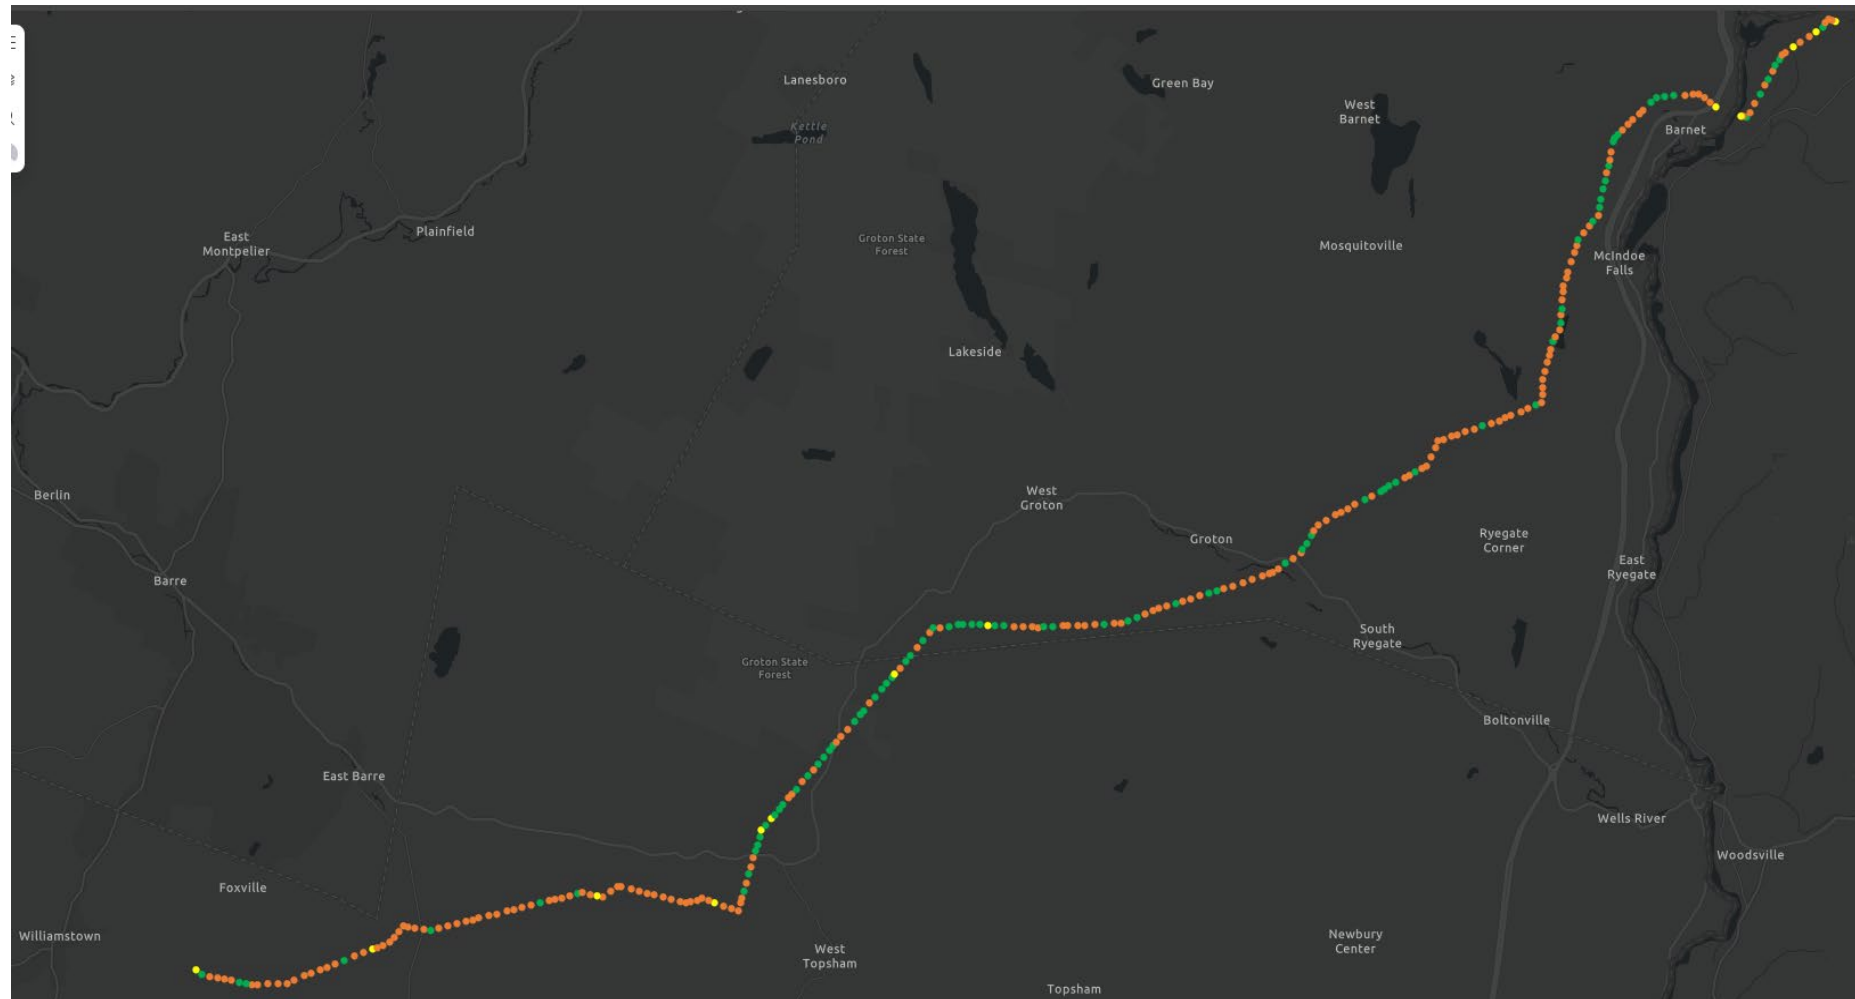
## Power BI Structure Condition Dashboard Heat Map - F206

- The F206 230 kV transmission line has a high percentage of structures with deficiencies identified through drone imagery and ground line inspections. Currently, 181 of the 277 structures on the line (or 65%) are rated C. This project will replace the degraded structures and retain the A and B rated structures.

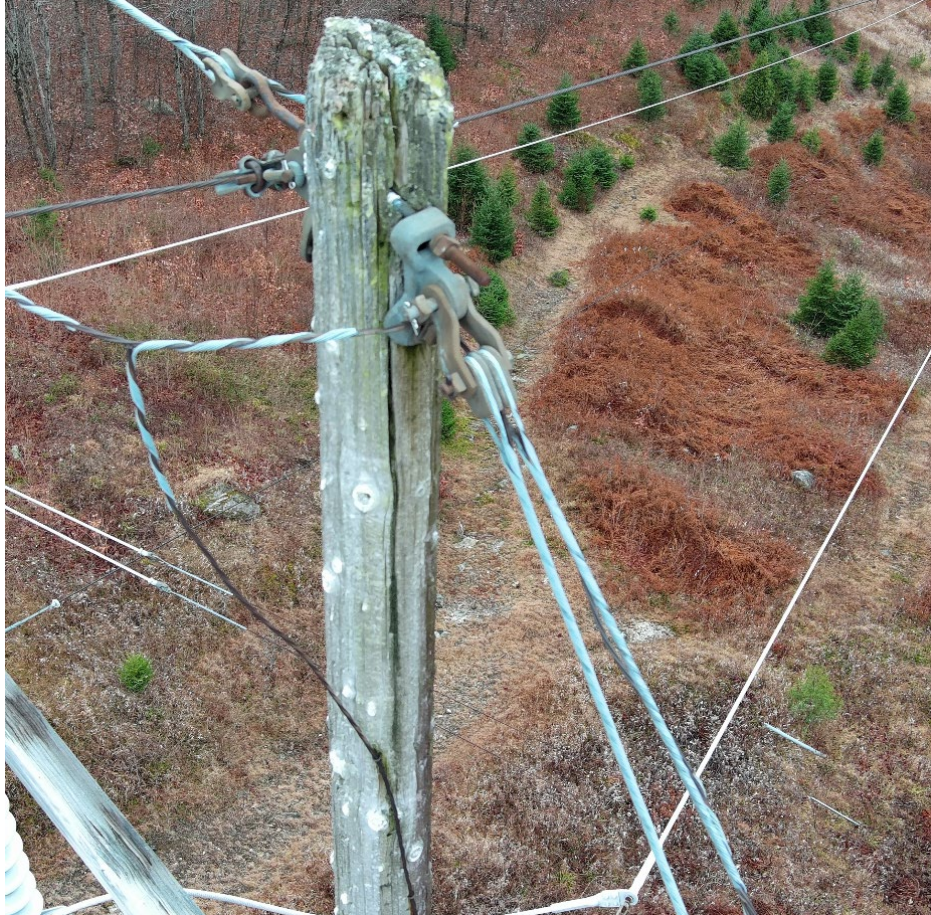
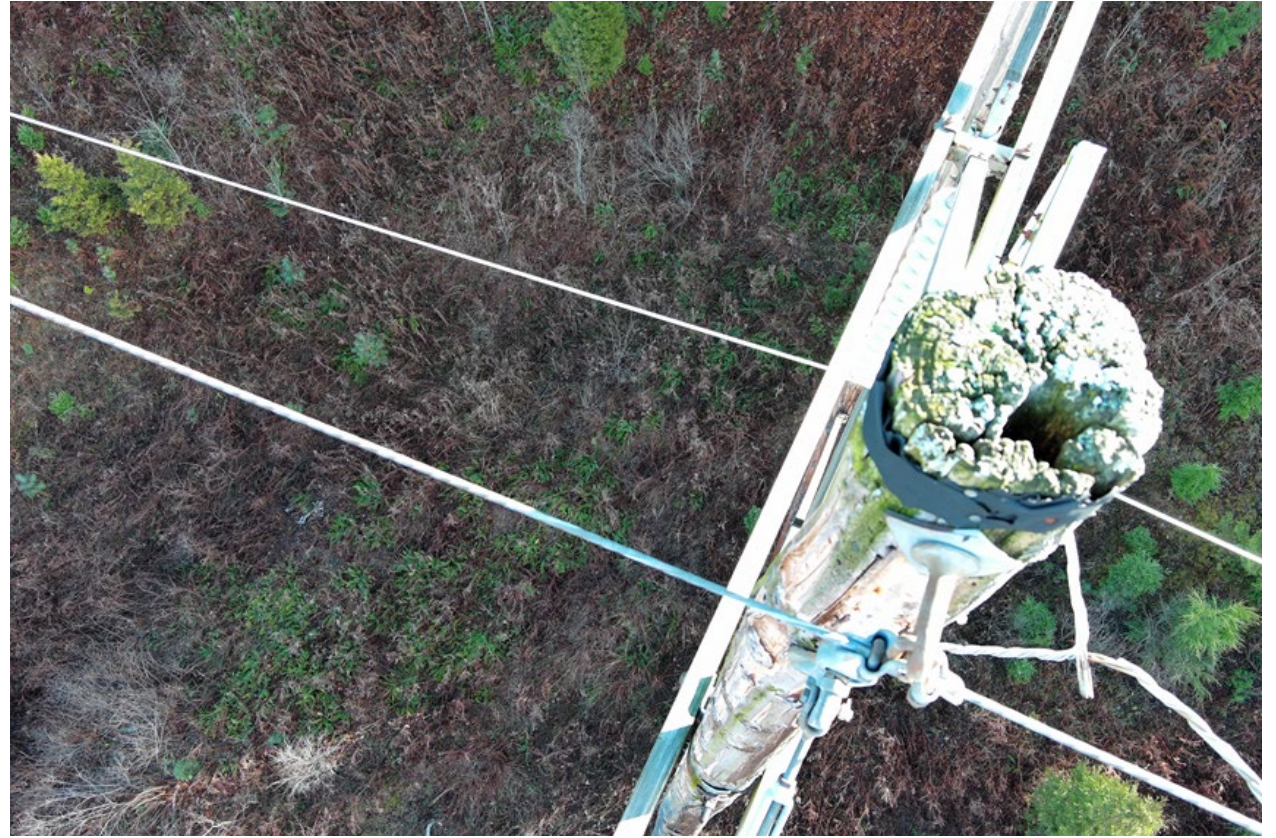
Structures - major pole decay and deterioration on the original 1971 poles

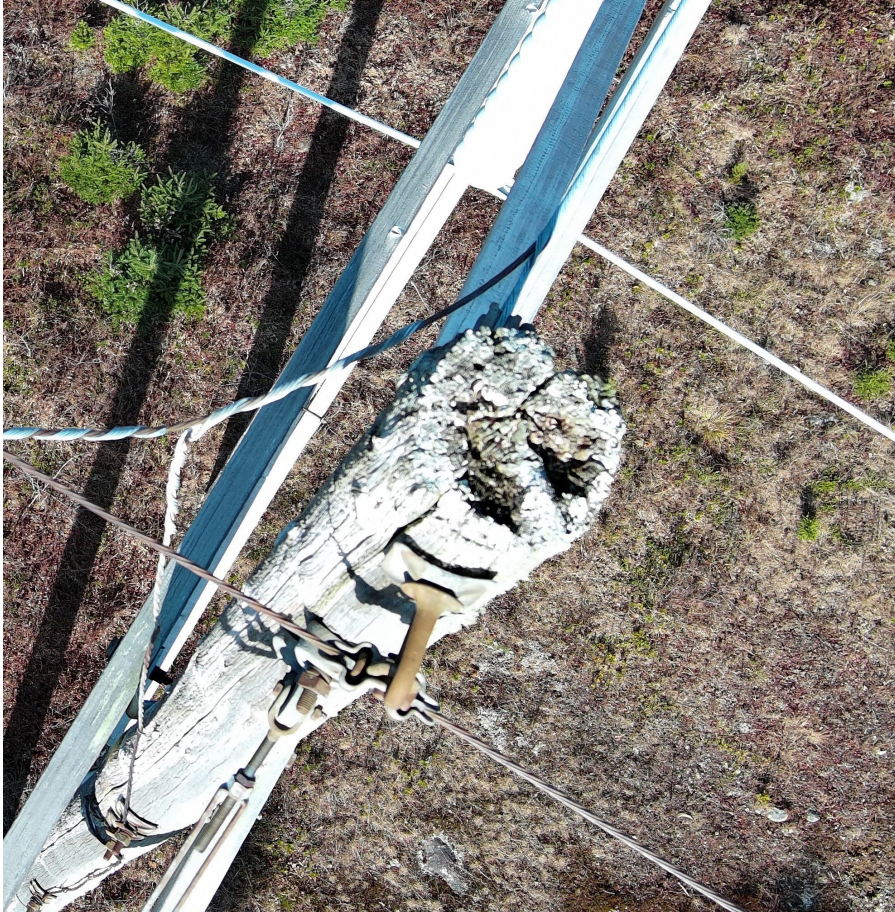
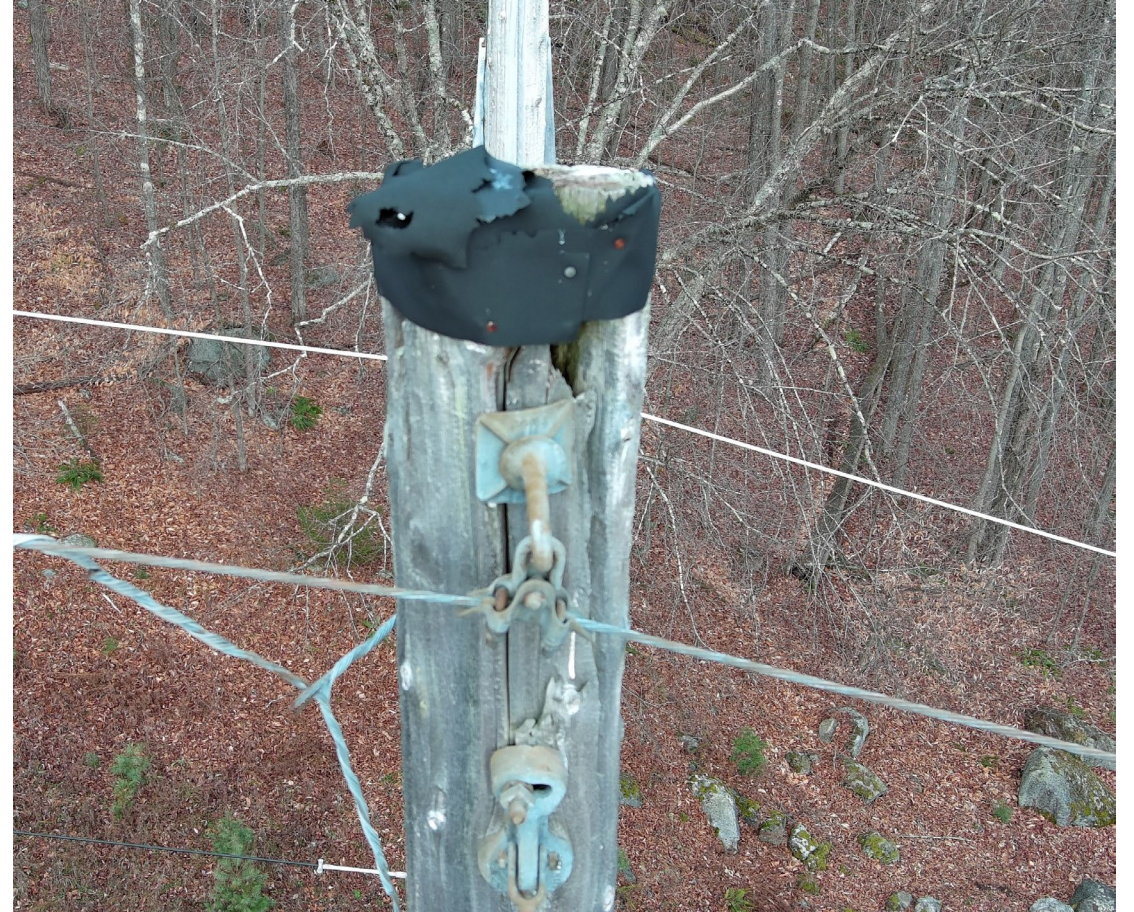
Structures - major pole decay and deterioration on the original 1971 poles

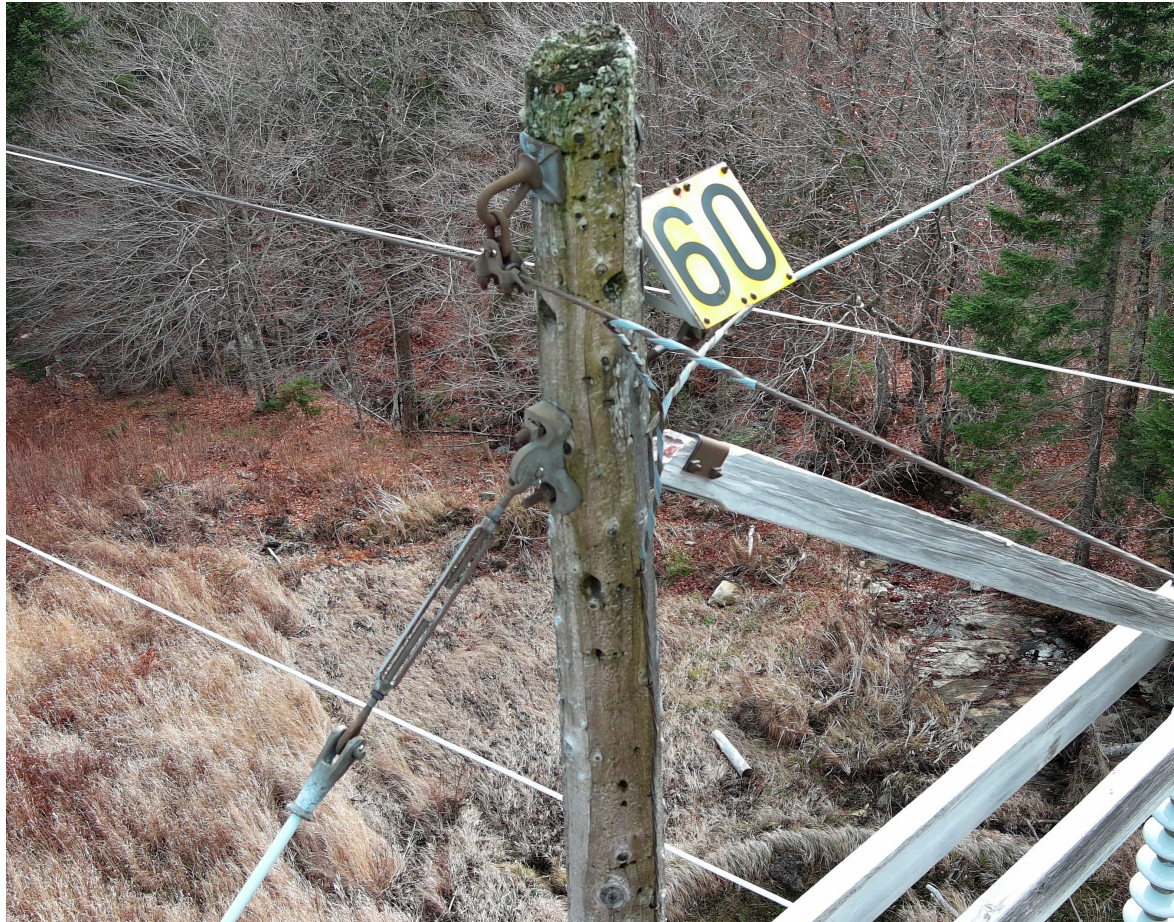
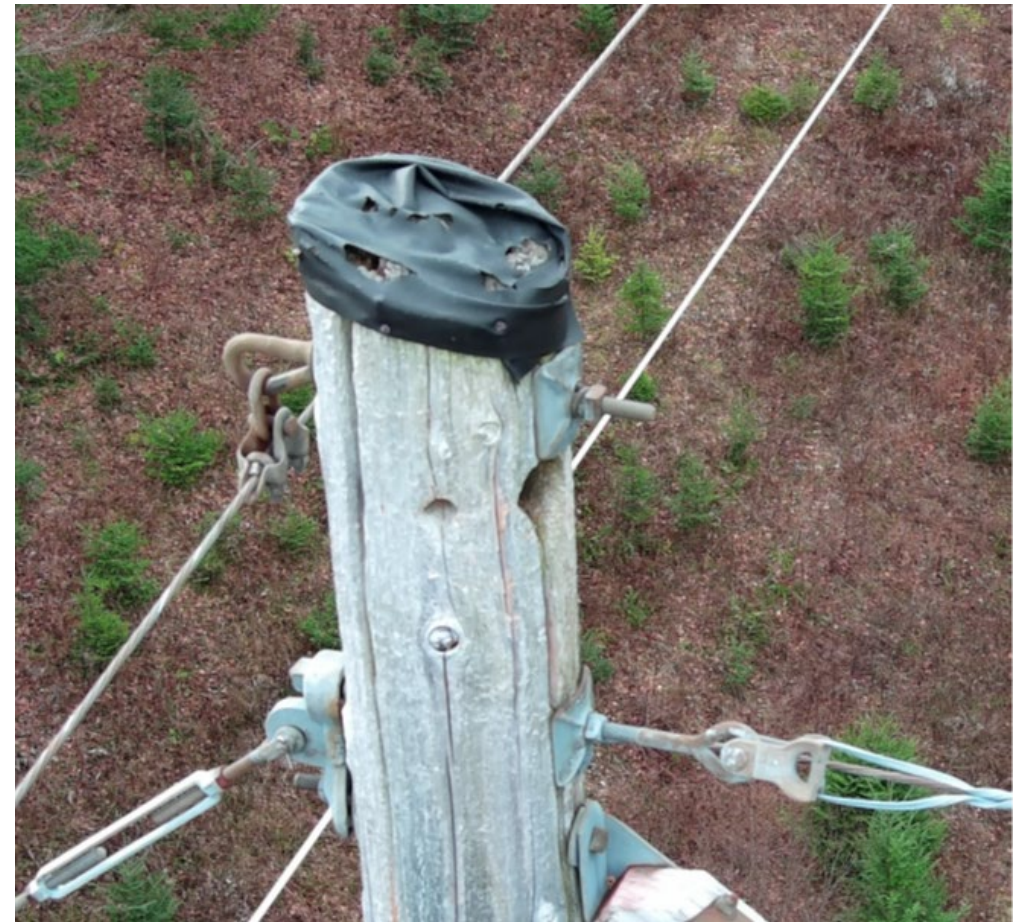
Structures - significant woodpecker damage throughout the line

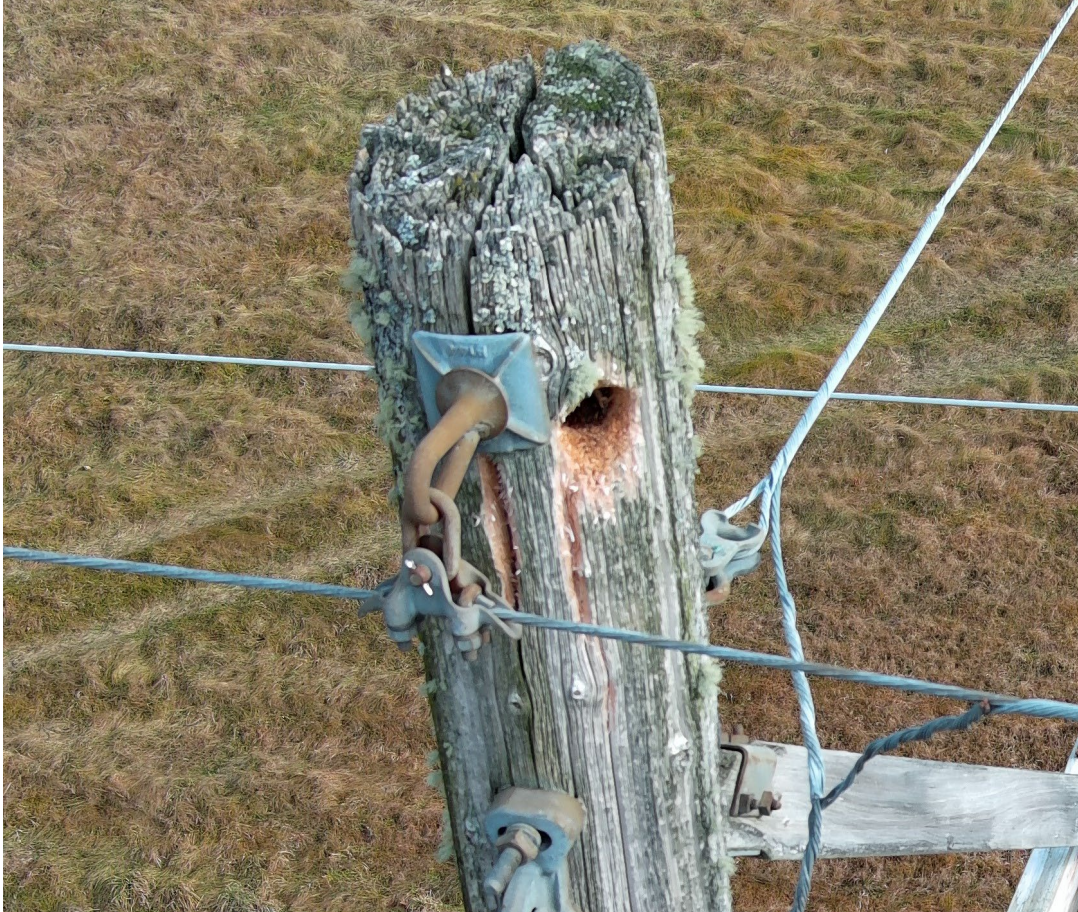
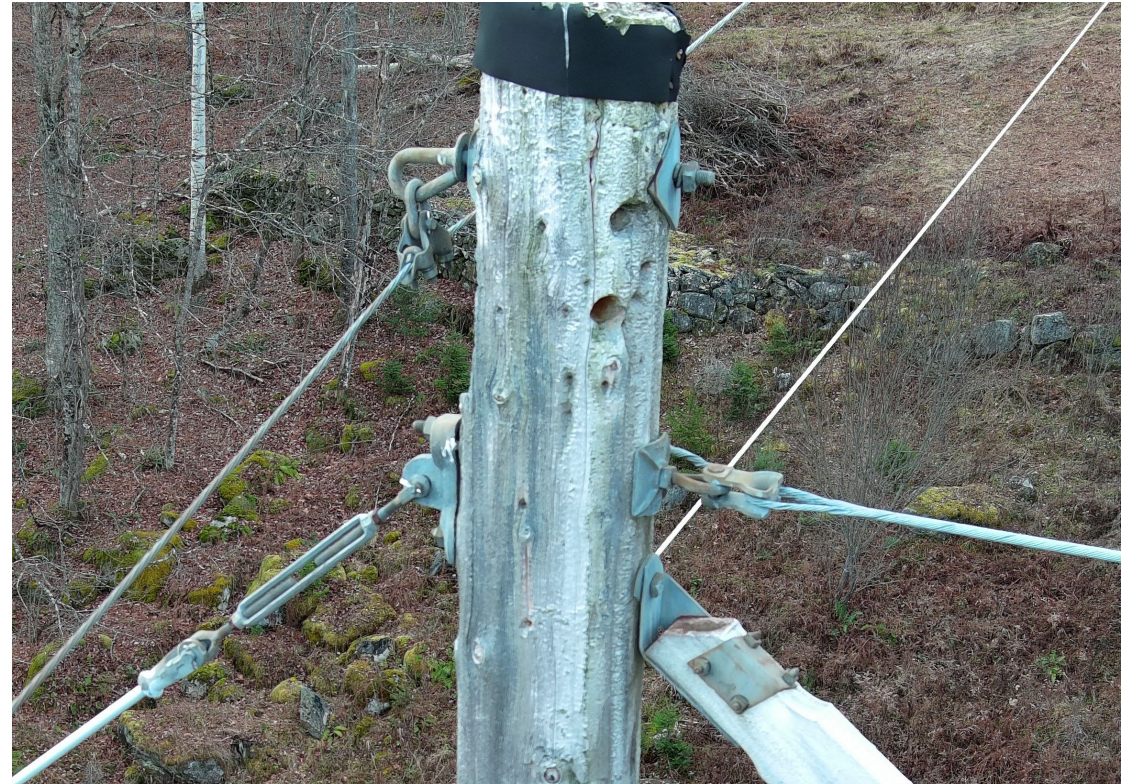
Structures - significant woodpecker damage throughout the line
